Report Title: Foreshore Trust Playground Renewal Scheme 2024/25

Appendix A – For context purposes, extract of annual external play equipment inspection undertaken in May 2023 highlighting increasing wear and tear, plus items out of use and nearing end of service life etc.

CLIENT: Hastings Borough Council
 SITE: Pelham Beach Wrecked Ship
 Inspection date: 27-30/03/2023
 Report date: 26/04/2023

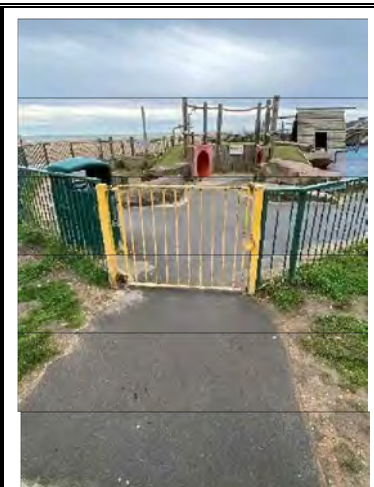
TOTAL	Risk level	Risk level	Risk level	Risk level	Risk level
Issues or hazards found					
	Trivial	Tolerable	Moderate	Substantial	Intolerable
		low	medium	high	immediate
a. East gate	1		1		
RL Moderate	Protruding fixing to buffer

Hazard	How harm could occur	Actions to control the risk
Protruding fixing	Contact injury	Refit or renew

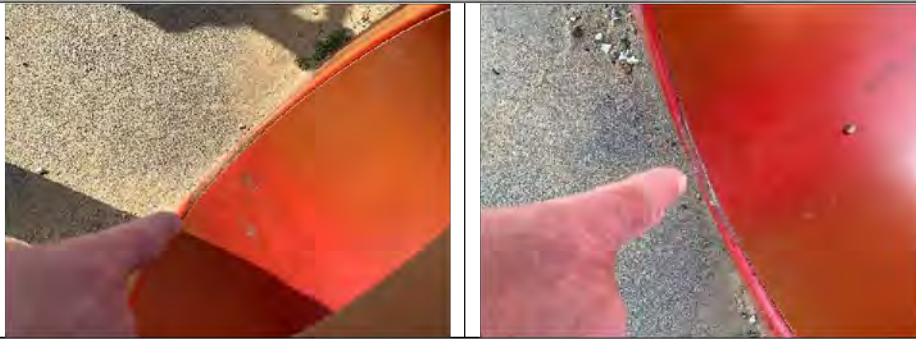
1- U tunnel	2		1		
-------------	---	--	---	--	--

RL Moderate tunnel exit edges worn

The edges of the tunnel are worn and the protective gel coat is damaged enabling the construction fibre beneath to become exposed with further wear/usage. Replacement or repair needed

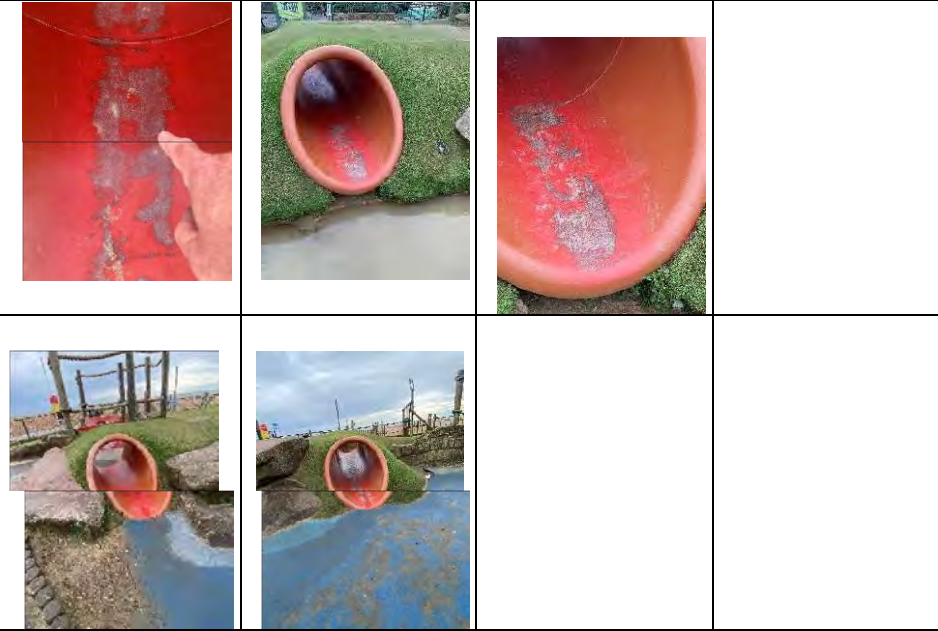
2- Side tunnels	3		1		
------------------------	---	--	---	--	--

RL Moderate tunnel inside surfaces worn

BS EN 1176-1			
HSE considerations where the identified issue is advised to be a hazard			
Hazard	How harm could occur	Actions to control the risk	
Contact with sharp fibres	Contact injury	Monitor regularly and remove from use if any fibres become exposed	
Assessing the level of risk

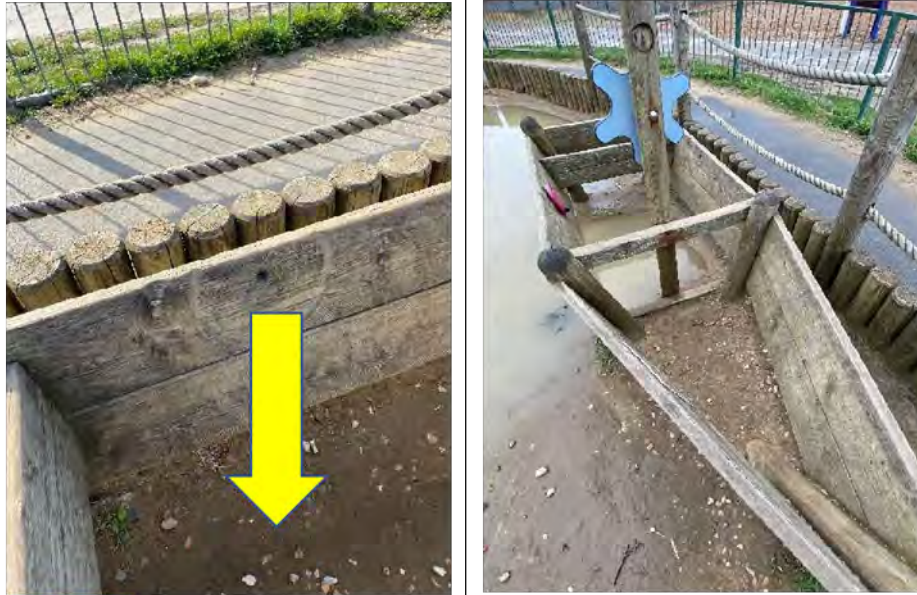
RL Moderate The inner floor of the ship contains sharp exposed stones. Re-provision of the sand is needed

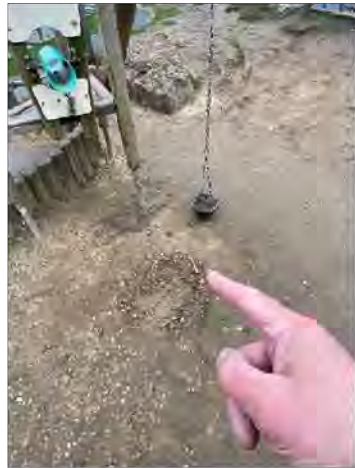
4- Sand hoist	3		1	1	
RL Moderate	Both sand tube fixings are severely corroded				
RL Substantial	Chain creates a strangulation hazard				
Issue	There is no sand provided for this item making it not able to be used

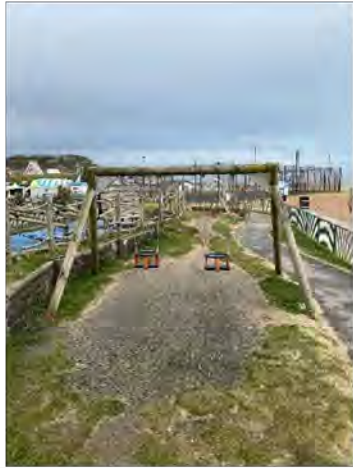
5- Swing 1 bay 2 cradle seats 1

Issue - cracks present in load bearing beam and other timber elements - review Section 10

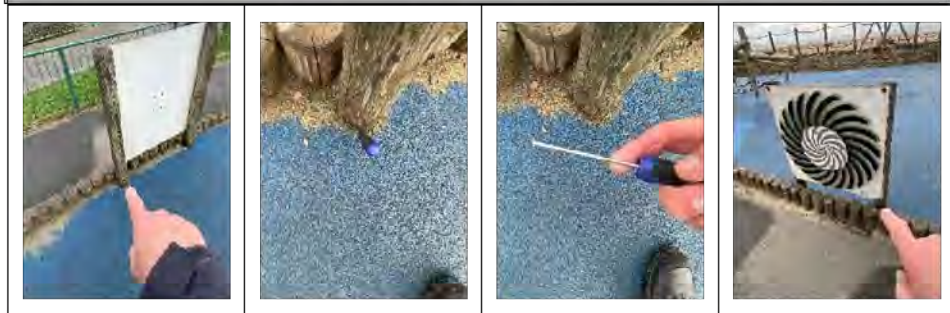
RL Intolerable rotten post reported from site

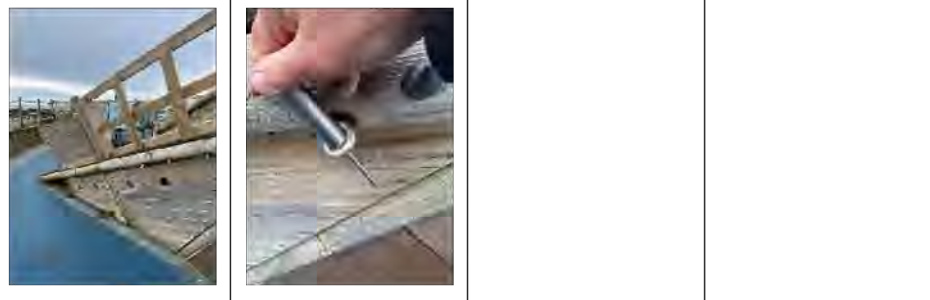
RL Tolerable with the mesh nets removed finger entrapments are left

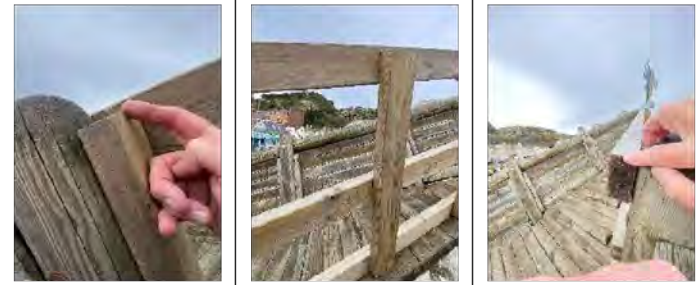
RL Moderate new timbers have radius edges of less than 3mm

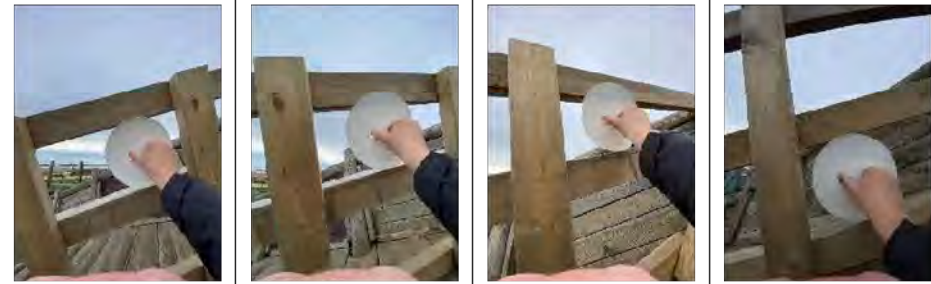
RL Substantial modified upper side design with railings has head entrapments

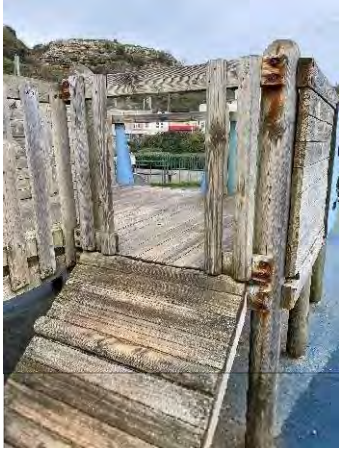
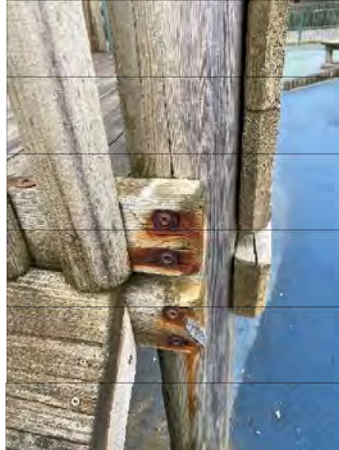
12-Central bridge structure	3			1	1
------------------------------------	---	--	--	---	---

RL Substantial Central bridge structure - Timber elements are starting to rot and fixings have corroded

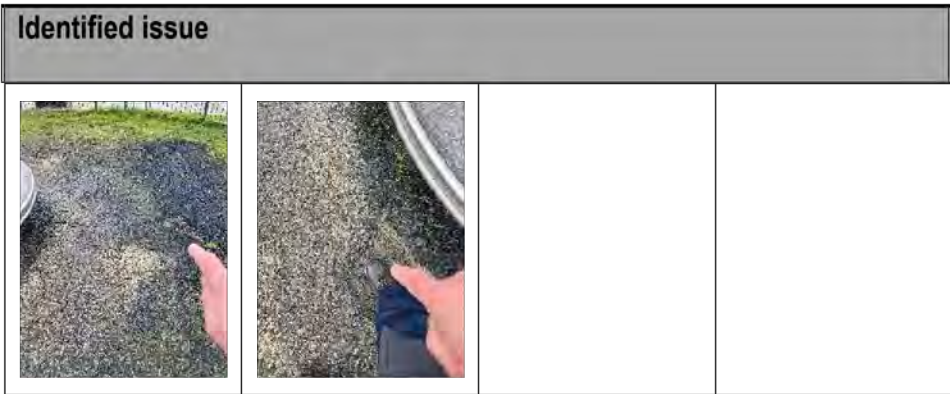
RL Substantial Significant areas of the IAS are damaged

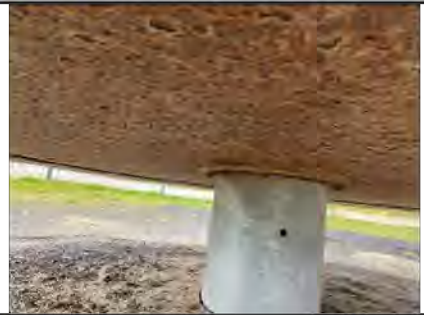
RL Intolerable Severe corrosion with indications of perforation to the underside of the carousel and central post

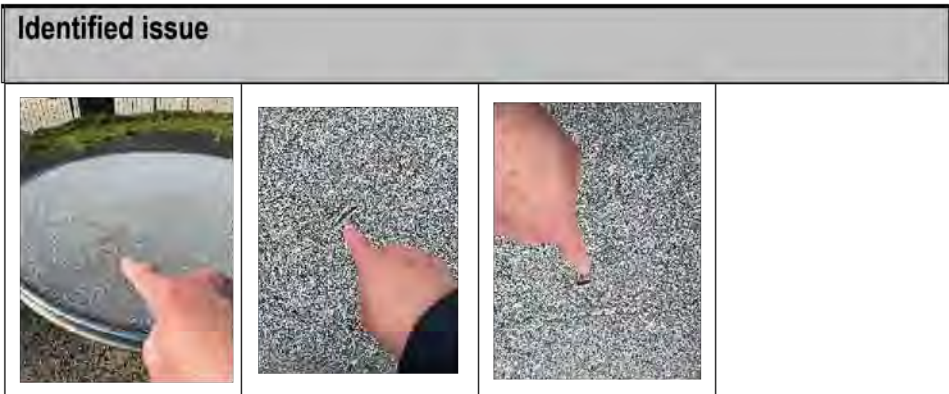
RL Substantial trip points developing on top of a moving carousel

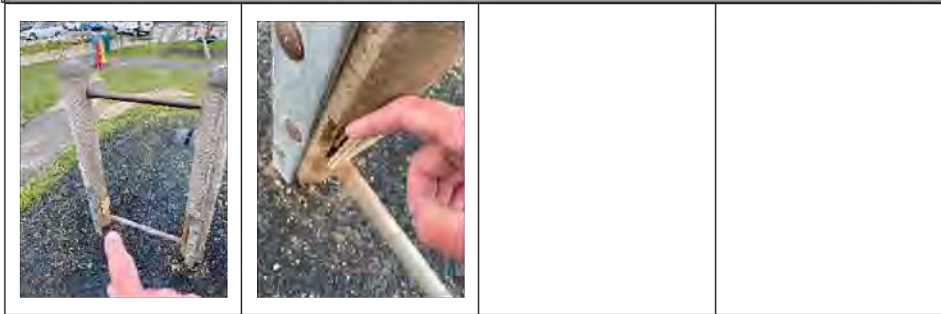
RL Moderate Protective panel is not secure
