SCH-009 Alexandra Park, Hastings, Cycle scheme

East Sussex Highways

Combined Stage 1/2 Road Safety Audit

7th October 2019

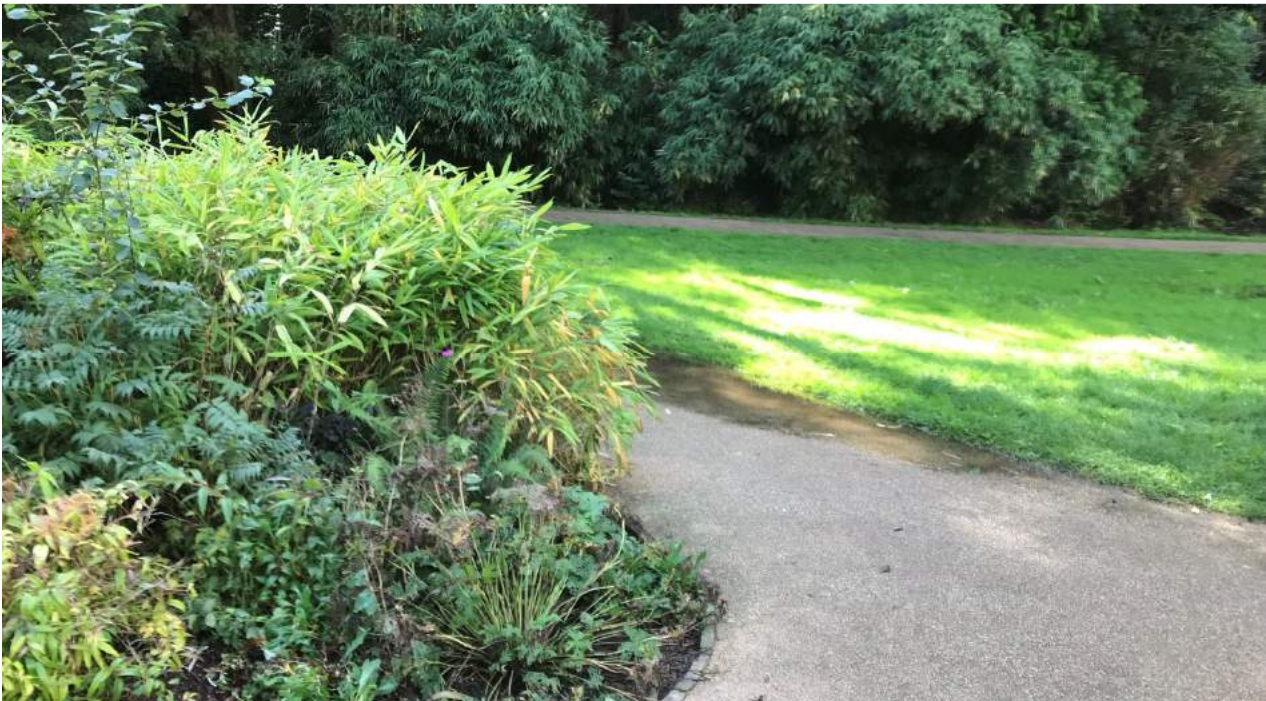
Location: Throughout scheme.

Summary: Insufficient forward visibility could result in collisions between users.

Through a combination of route alignment and vegetation there are a number of locations where forward visibility along the route is restricted, resulting in insufficient stopping sight distance for cyclists. This includes the first right hand bend when approaching from Strood Road, the sharp bend section at the switchback west of the Peace Garden and the right hand bend at the western end of the boating lake. Reduced forward visibility could result in conflicts between users at these locations, resulting in pedestrian and cyclist injuries.

Maximise forward visibility through the length of the scheme by cutting back the existing vegetation within the visibility splays and maintaining this as part of the park's maintenance programme.

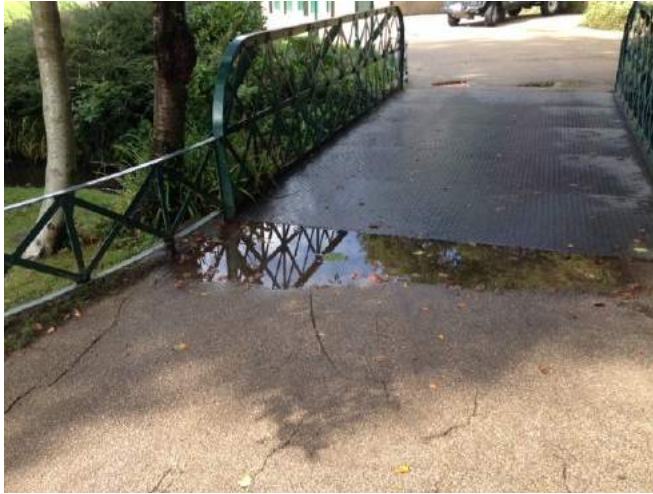
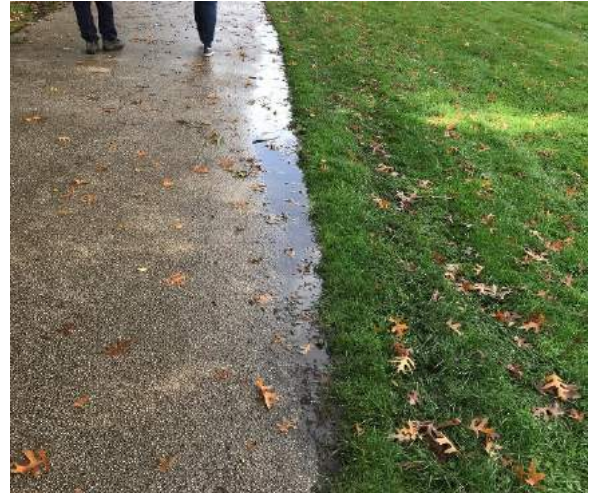
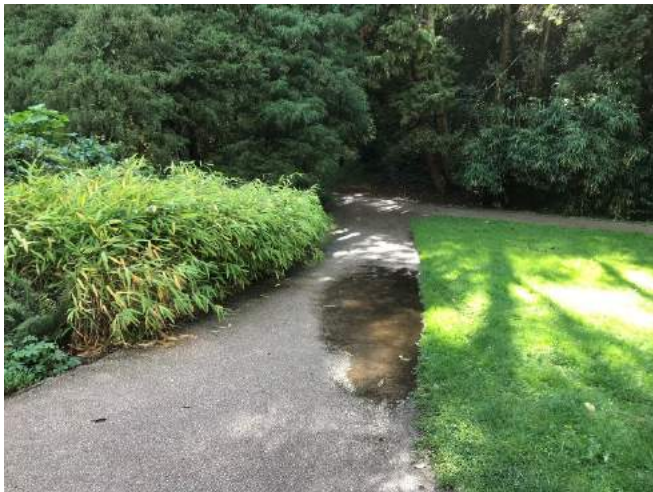
Location: Throughout scheme.

Summary: Ponding water observed on the proposed route, increasing the risk of slips, trips and unseated cyclists.

At a number of locations along the proposed route ponding water was observed following rainfall prior to the site visit. The images below show ponding at the bridge near the bandstand, the path alongside the bowling green and at the switchback west of the Peace Garden. Ponding water increases the risk of pedestrians slipping/tripping and cyclists being unseated. During cold weather conditions the risk could increase if the ponding water freezes.

It is recommended that suitable drainage is provided throughout the scheme to ensure that water does not pond within the shared route.

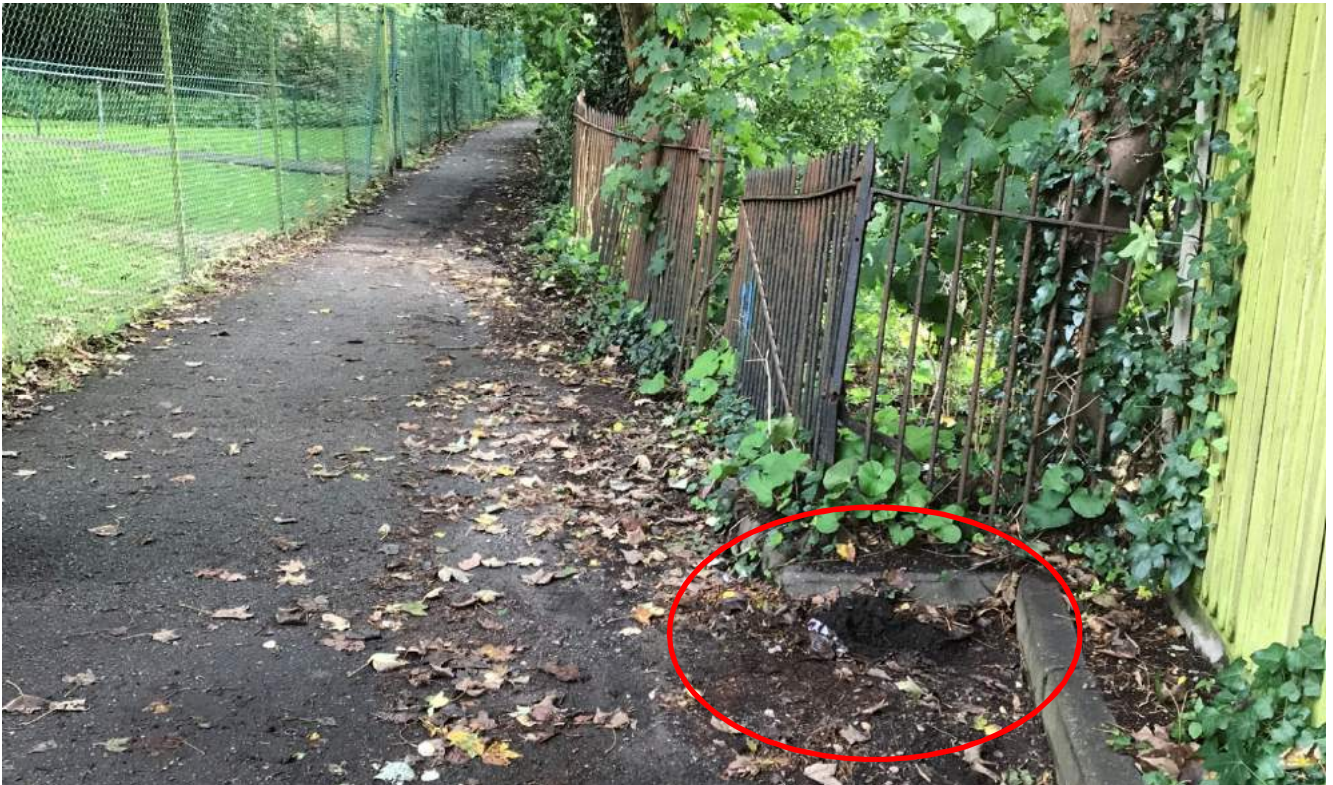
Location: Strood Road interface with shared path.

Summary: Blocked gully has led to a buildup of detritus and could result in ponding, increasing the risk of slips, trips and unseated cyclists.

At the interface between Strood Road and the shared route an existing gully was observed to be blocked. This has resulted in a significant buildup of detritus and mud and ponding is likely to occur during periods of sustained rainfall. Ponding water and a buildup of detritus across the path increases the risk of pedestrians slipping/tripping and cyclists being unseated. During cold weather conditions the risk could increase if the ponding water freezes.

It is recommended that the existing gully and detritus buildup is cleared and that additional drainage provided if the existing system is no longer effective.

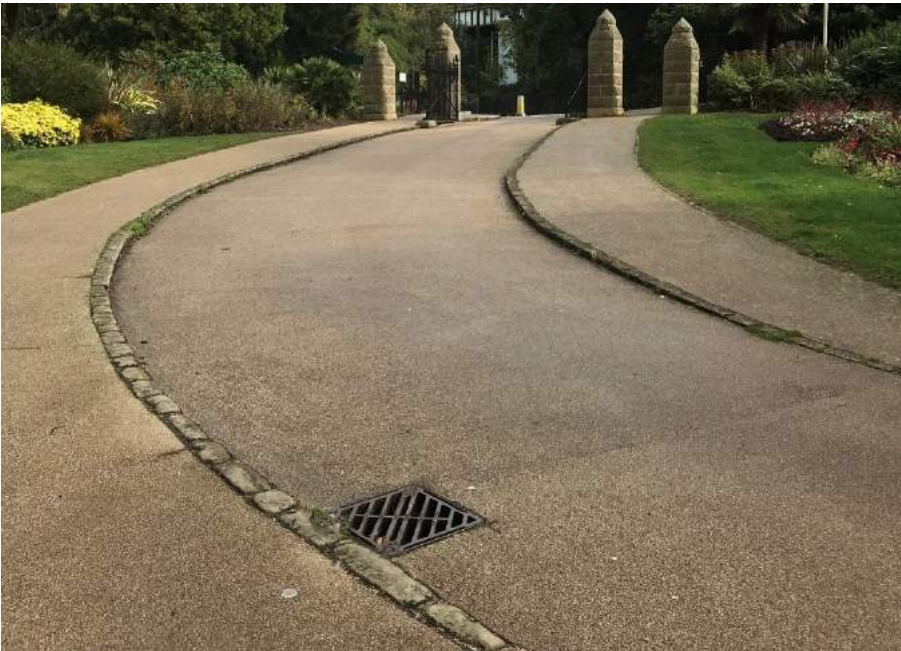
Location: Bethune way entrance.

Summary: Gully cover could trap bicycle wheels and unseat cyclists.

Cyclists entering the park and shared route from Bethune Way could cycle over an existing gully cover. Due to the type and orientation of the cover bicycle wheels could become trapped, resulting in cyclists being unseated.

It is recommended that the existing gully cover is replaced with a cycle friendly gully grate.

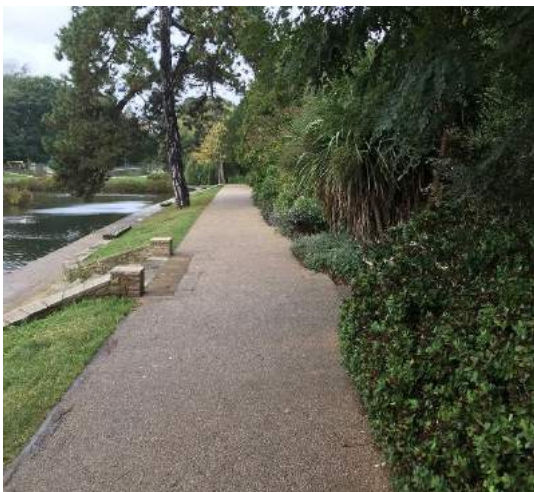
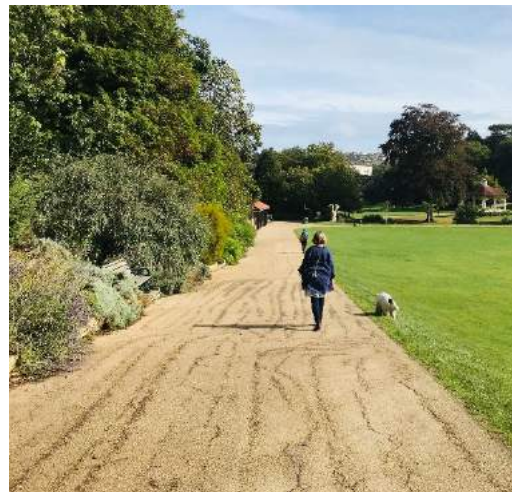
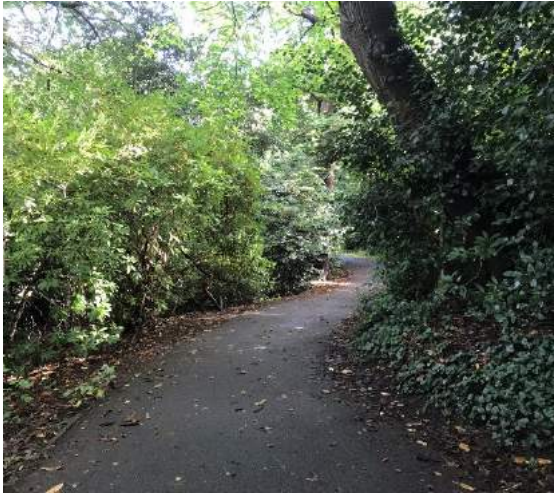
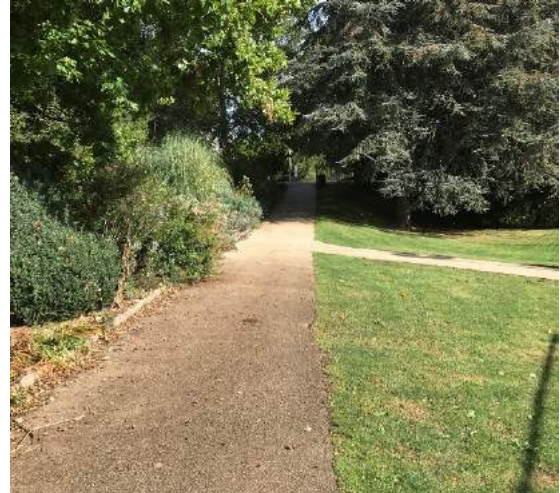
Location: Throughout scheme.

Summary: Bordering vegetation encroaches across the shared route, restricting the effective width.

Throughout the park the proposed shared route is bordered by vegetation, including flower beds, shrubs, bushes and trees. During the site visit it was observed at a number of locations, including those not specified for widening, that vegetation encroaching across the footway would restrict the effective width of the proposed shared route. This could increase the risk of conflicts between users.

It is recommended that all encroaching vegetation is removed and that the width of the full route is maintained year round through regular inspections and clearing as part of the park's maintenance programme.

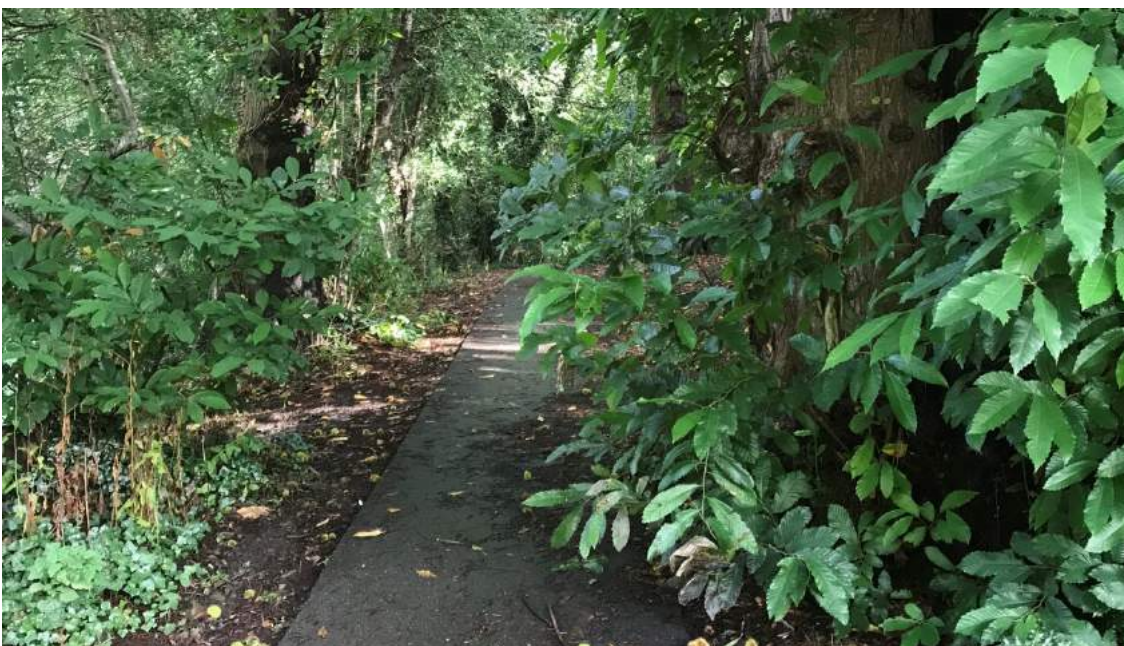
Location: Shornden Wood near sign S11.

Summary: The shared route at a reduced width location is impacted by an existing tree.

The shared route east of sign S11 in Shornden Wood is 2m wide over a short length. A tree bordering the shared route reduces the width further due to low level growth. This impacts on the available width and intervisibility between users, which could increase the risk of collisions.

It is recommended that the width of the shared route is maximised at this location by removing all encroaching vegetation. Ensure that the width of the full route is maintained year round through regular inspections and clearing as part of the park's maintenance programme.

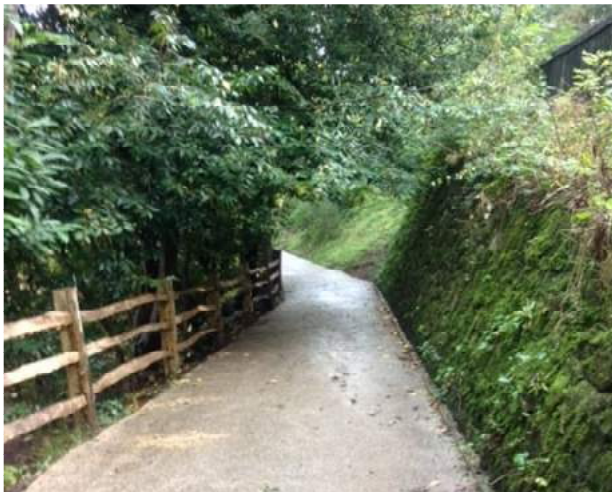
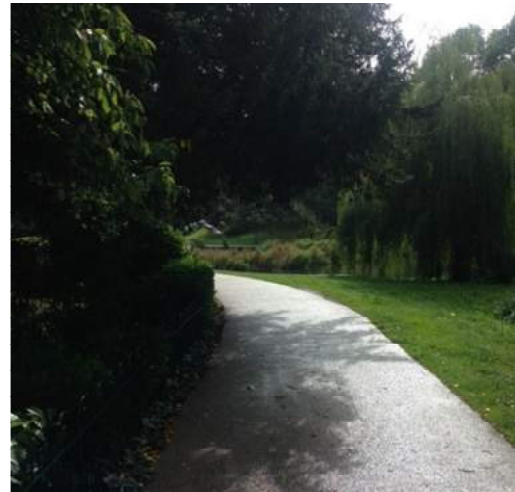
Summary: Tree canopies overhanging the shared route could potentially unseat cyclists.

At a number of locations tree canopies overhang the proposed shared route, increasing the risk of cyclists striking low hanging branches and becoming unseated.

It is recommended that low hanging branches are removed to provide a minimum headroom of 2.4m.

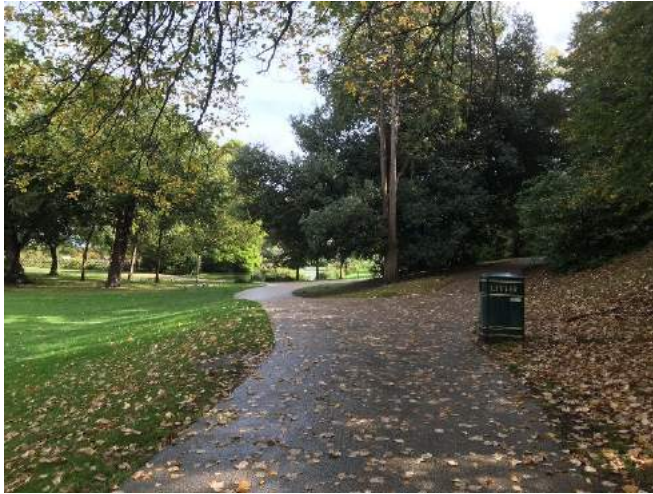
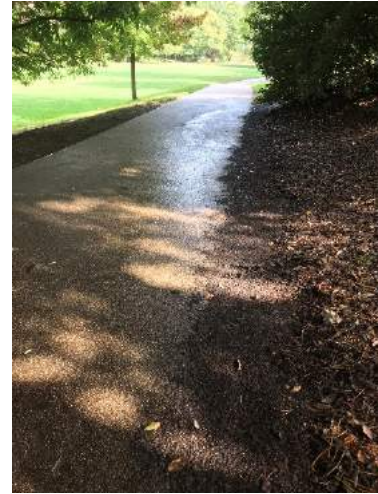
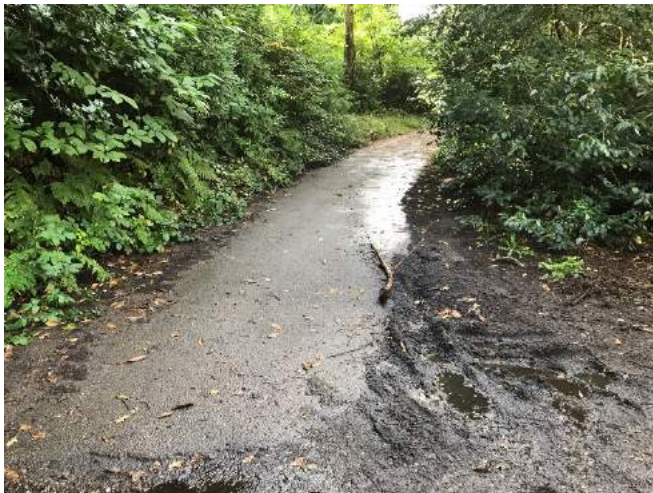
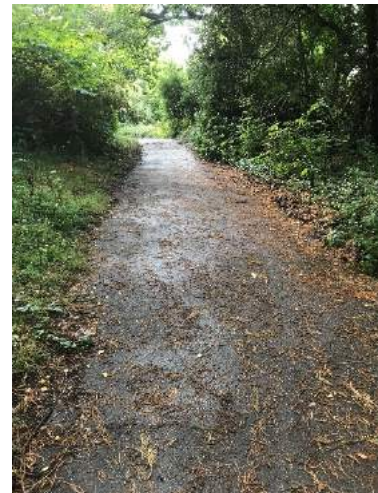
Summary: Material from adjacent banks and vegetation could result in pedestrian slips, trips and falls and unseated cyclists.

The proposed shared route is largely bordered by grass banks and vegetation including flower beds, shrubs, bushes and trees. During the site visit it was observed that loose material from adjacent banks and bordering and overhanging vegetation (needles, leaves, flowers etc.) encroaches/falls onto the paths. This increases the risk of pedestrian slips, trips and falls and unseated cyclists, particularly on steep parts of the route.

The impact of loose material from banks and vegetation is likely to increase during autumn as leaves are dropped from trees in combination with increased rainfall.

It is recommended that existing loose material, needles, leaves, flowers etc. are removed from the proposed route and that the route is kept free from debris year round through regular inspections and clearing as part of the park's maintenance programme.

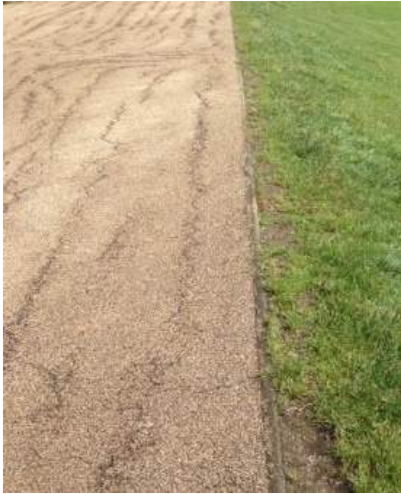
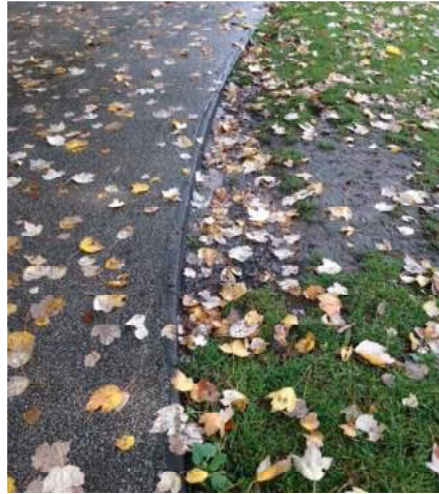
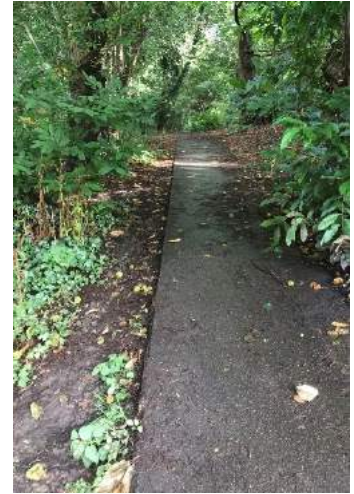
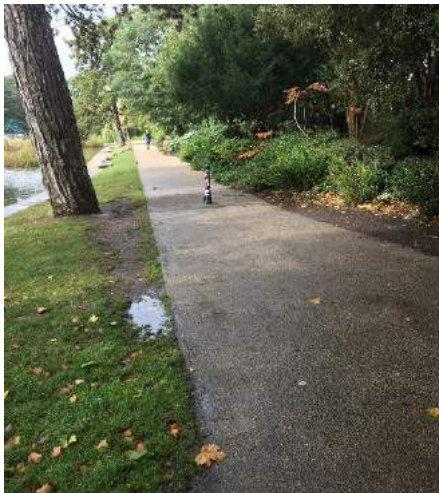
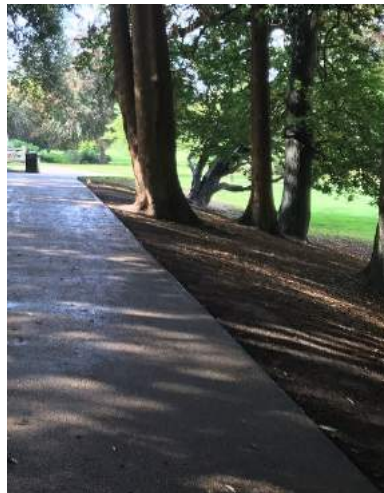
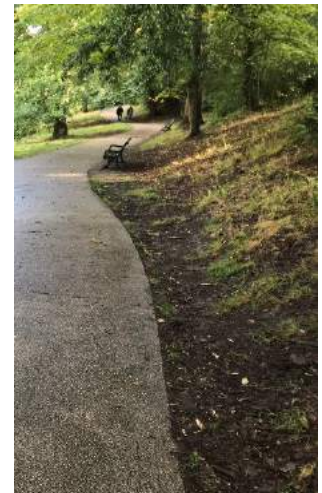
Location: Lower park.

Summary: Changes in levels at the edge of the proposed shared route could unseat cyclists.

Within the lower park section, it was observed that there are existing changes in levels where the shared route and grass verges interface. If a cyclist's wheel left the shared route at these locations, the sudden change in level, often on a muddy surface, could lead to cyclists losing control increasing the risk of unseated riders and injuries.

It is recommended that level differences are removed using earthworks/top soiling along the length of the route.

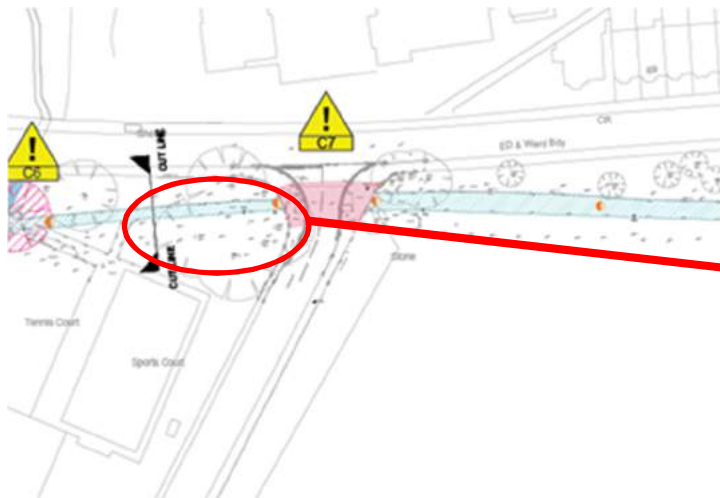
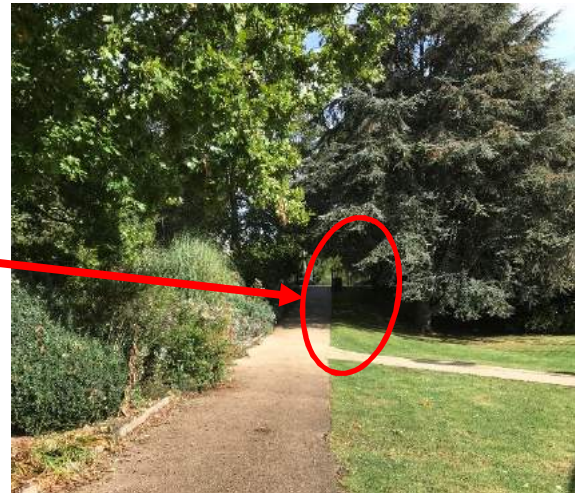
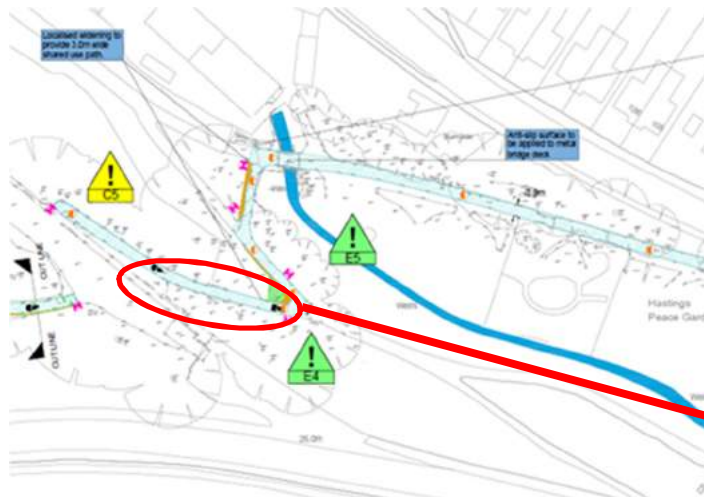
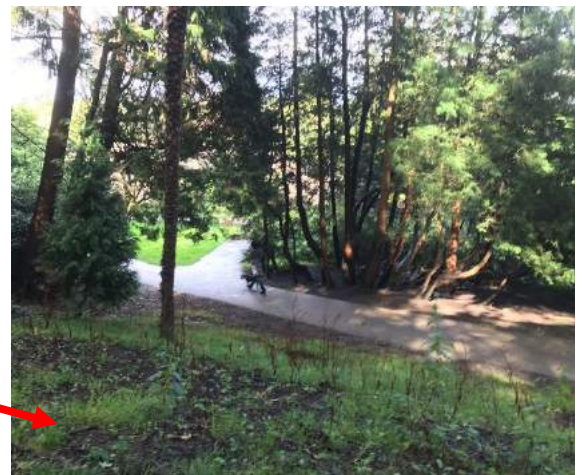
Location: West of the Dordrecht Way carriageway crossing and at the shared route switchback west of the Peace Garden.

Summary: Lack of protection of steep banks could increase the severity of injuries should a cyclist leave the shared route.

Step banks are immediately adjacent to the proposed shared route to the west of the Dordrecht Way carriageway crossing and at the shared route switchback west of the Peace Garden. The gradient of these steep banks could increase the severity of injuries to a cyclist should they leave the shared route.

It is recommended that 1.4m high timber post and rail cleft fencing is provided at these locations, consistent with protection of steep banks at other locations along the route.

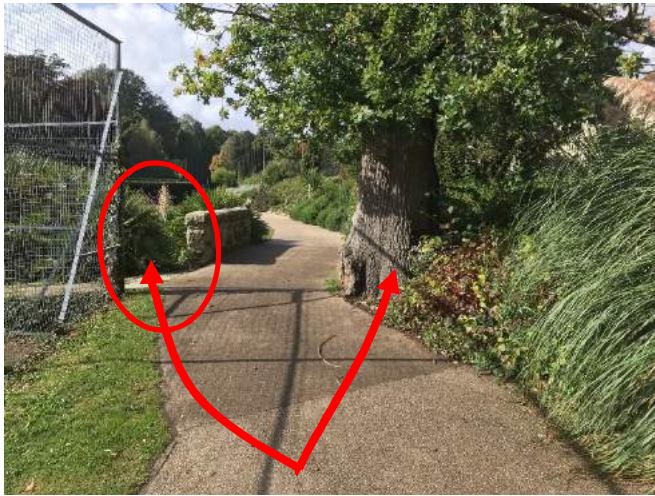
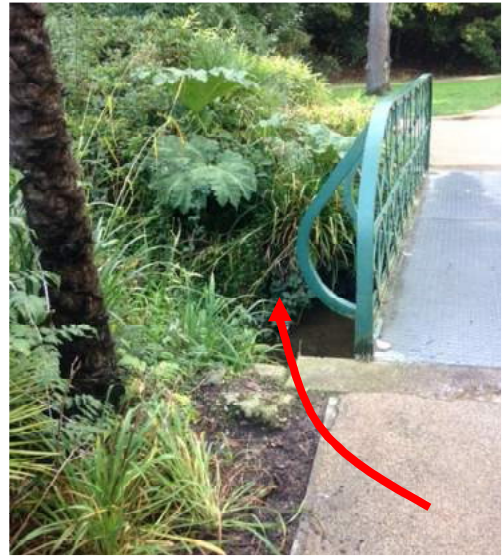
Location: Existing bridges without extended parapets.

Summary: Gaps at bridge parapets could increase the severity of injury should a cyclist leave the shared route path at these locations.

Some of the existing bridges are fitted with additional sections of extended parapet, which act as a physical barrier and guide to users, protecting them from steep drops into waterways. It was observed during the site visit that additional sections of extended parapet are omitted at other bridges along the route which could result in an increased risk of injury and severity should a cyclist leave the shared route.

A gap is also likely to be created at the stone bridge parapet when the proposed tree removal has been undertaken.

It is recommended that additional sections of extended parapet are provided at all bridges with adjacent gaps/steep drops into waterways.

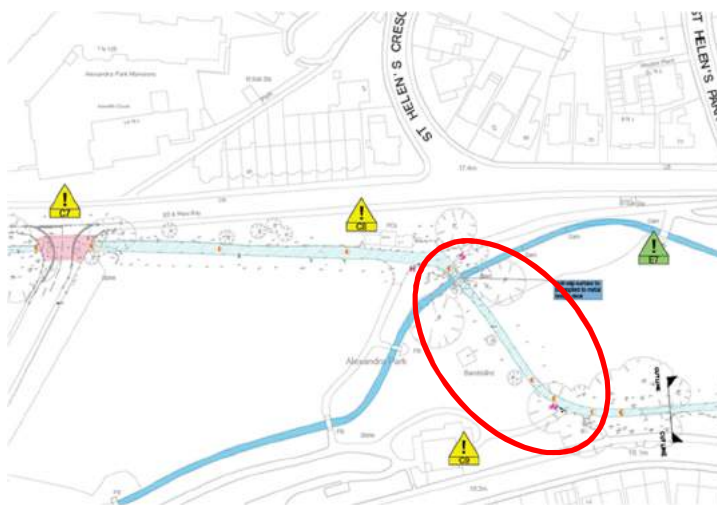
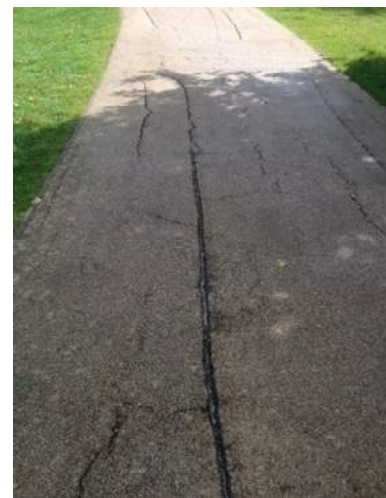
Location: Shared path adjacent to the bandstand.

Summary: Longitudinal cracking in the surface could result in cyclists being unseated.

The section of shared path adjacent to the bandstand is not due to be resurfaced. During the site visit longitudinal cracking was observed in this section. The cracks were, in places, wide enough to accommodate a bicycle tyre which could trap bicycle wheels and unseat cyclists.

It is recommended that the longitudinal cracks are sealed or this section resurfaced to provide a smooth, consistent surface for cyclists.

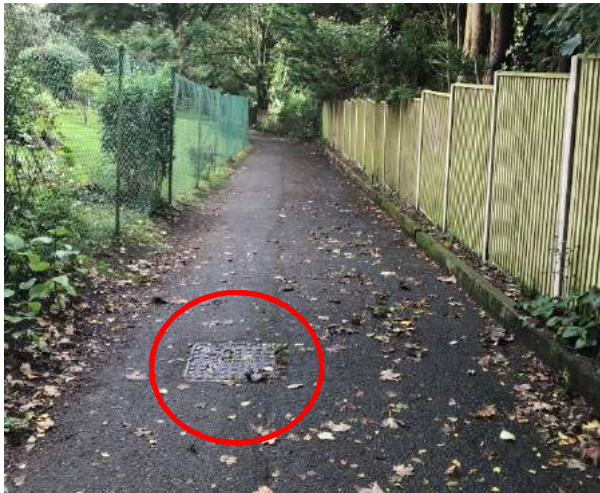
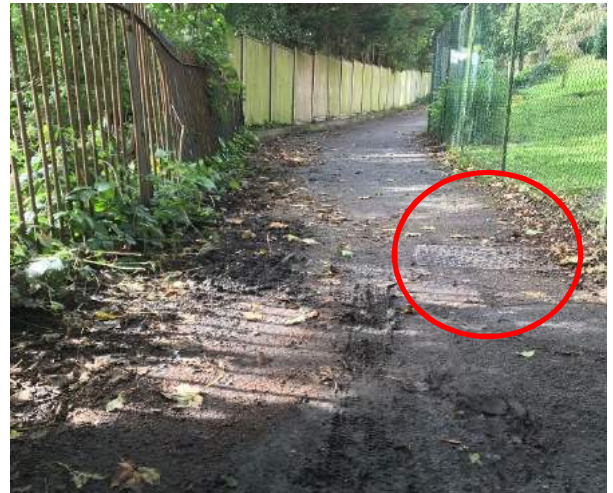
Location: Strood Road interface with shared route.

Summary: Utility covers could result in pedestrian slips and unseated cyclists.

At the interface between Strood Road and the shared route there are two utility covers which are likely to become slippery when wet. This increases the risk of pedestrian slips and cyclists, particularly those braking on approach to the staggered barriers, being unseated.

It is recommended that the utility covers are treated so that they provide a consistent surface finish and skidding resistance to the shared route surface.

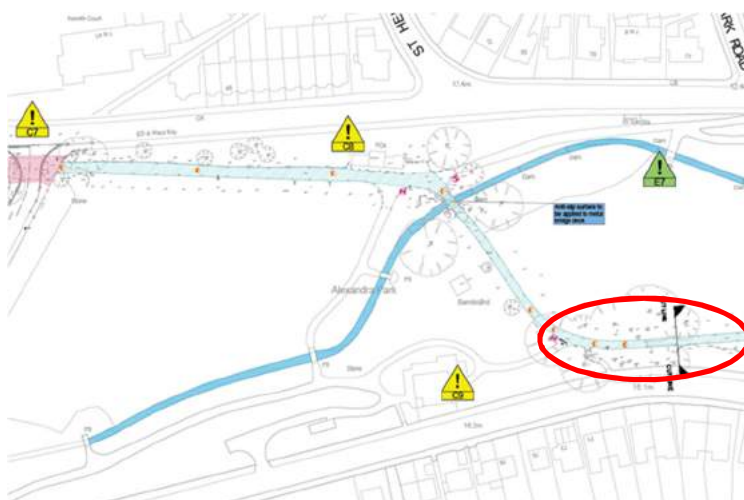
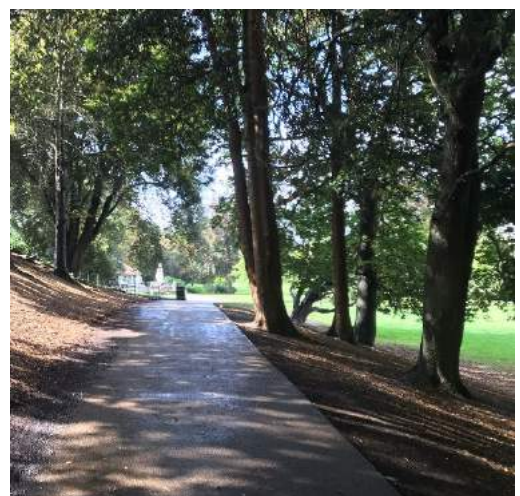
Location: Shared path east of the café.

Summary: Lack of contrast between the edge of route and verge could result in unseated cyclists.

The shared route to the east of the café is under dense tree cover and as a result is noticeably darker than other sections. Due to the tree cover, grass does not grow in the verge at the edge of the route. This results in a lack of contrast between the edge of route and the adjacent downhill bank, increasing the risk of cyclists leaving the route and becoming unseated. The lack of contrast is likely to be exacerbated at dusk and dark conditions.

It is recommended that the edge of the route is demarcated for the section under tree cover.

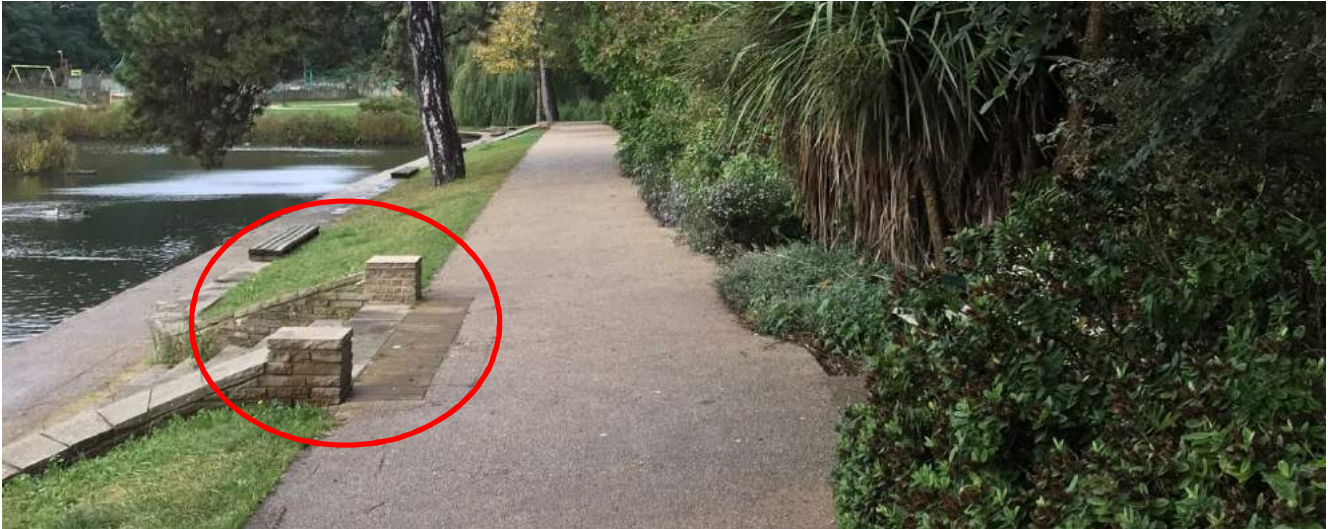
Location: Shared path adjacent to the boating lake at the eastern end of the lower park.

Summary: Potential for bicycle pedals to strike the top of steps, resulting in unseated riders.

At the eastern end of the route two sets of steps connect the proposed shared route and a pedestrian path alongside the boating lake. The tops of the steps are vulnerable to being struck by bicycle pedals, which could result in unseated riders. The risk of strikes could increase during dusk/dark conditions as the step tops do not contrast with the route.

It is recommended that demarcation around the top of the steps is provided.

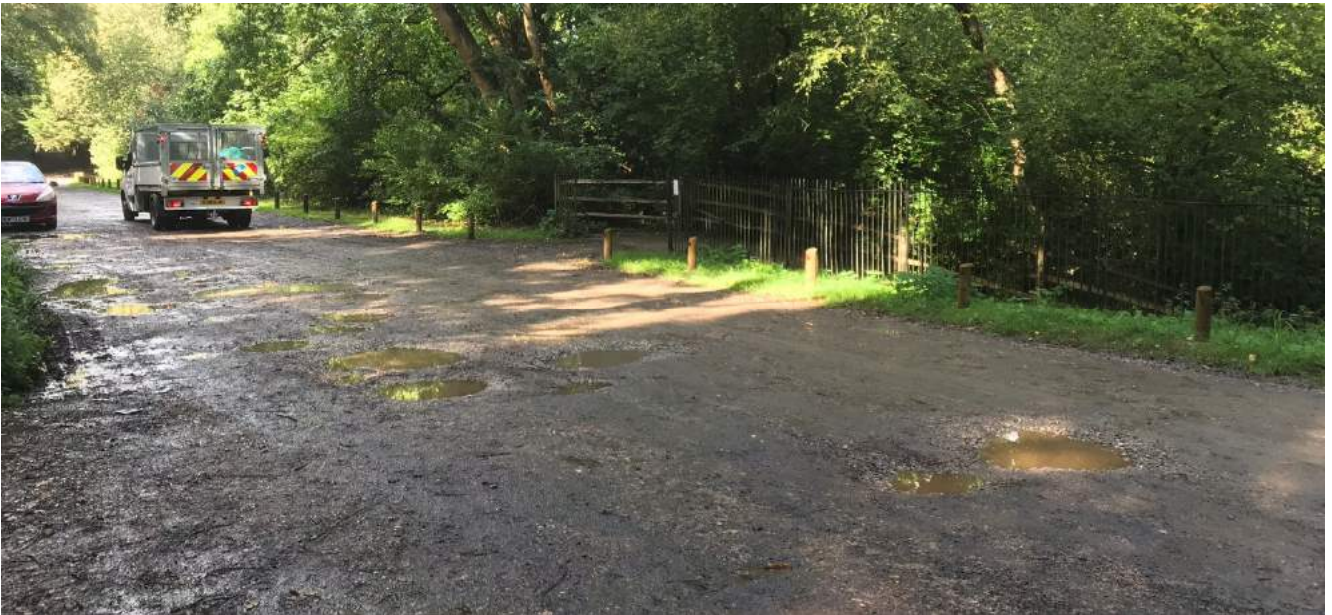
Location: Link between the upper park and lower park.

Summary: Poor quality surface and lack of route clarity.

The shared route link between the upper and lower park crosses an ambiguous area with an unbound and poor quality surface subject to ponding. The area is used by vehicles, pedestrians and cyclists, but it is unclear who has priority. In addition, the proposed signing and markings do not provide clarity of the onward route. The combination of these problems could result in collisions between pedestrians, cyclists and vehicles.

It is recommended that a surface consistent with the rest of the shared route is provided along with signs and markings to address the route ambiguity and continuity concerns.

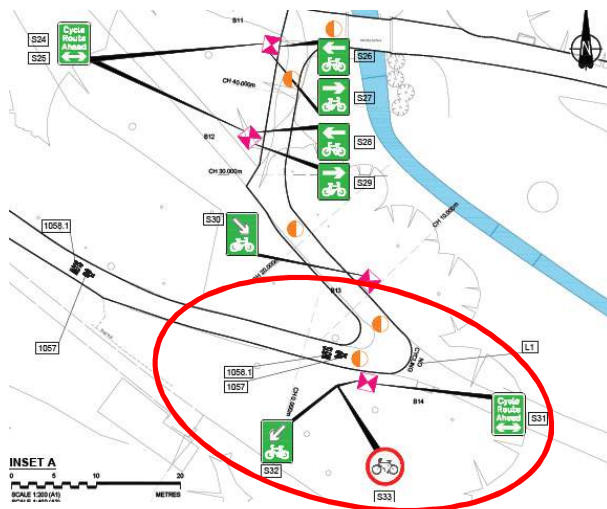
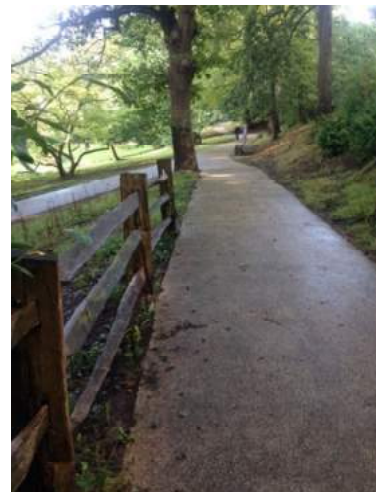
Location: Switchback west of the Peace Garden.

Summary: Lack of route clarity could result in cyclists continuing away from the shared route.

At the switchback, signing is proposed. If approaching the switchback from the west the alignment of the path and conflicting signing of the onward route and 'no cycling' on the same side of the bollard could result in cyclists continuing away from the shared route on a less suitable path, increasing the risk of conflicts with pedestrians.

It is recommended that the proposed signing and markings are revised to address the route ambiguity for cyclists.
