Report Title: Foreshore Trust Playground Renewal Scheme 2024/25

Appendix A – For context purposes, extract of annual external play equipment inspection undertaken in May 2023 highlighting increasing wear and tear, plus items out of use and nearing end of service life etc.

CLIENT: Hastings Borough Council
 SITE: Pelham Beach Wrecked Ship
 Inspection date: 27-30/03/2023
 Report date: 26/04/2023

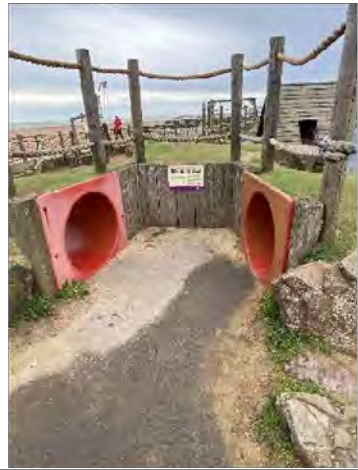
1- U tunnel	2		1		
-------------	---	--	---	--	--

RL Moderate tunnel exit edges worn

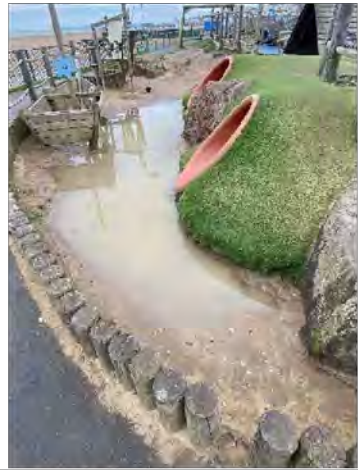
2- Side tunnels	3		1		
------------------------	---	--	---	--	--

2- Side tunnels	3		1		
<p>RL Moderate tunnel inside surfaces worn</p> <p>Action Analysis <input type="checkbox"/> infill relevant box <input type="checkbox"/> Action immediately - now implement <input type="checkbox"/> Already actioned <input type="checkbox"/> Plan work and implement <input type="checkbox"/> Monitor - no action is currently required <input type="checkbox"/> Review</p> <p>Brief description of the work actioned e.g. repair, remove, replace, renovate, investigate, modify, fence off, clean, top-up</p>					
<p><input type="checkbox"/> Work completed Name Click or tap here to enter text. Date Click or tap to enter a date.</p>					
<p>Issue The ground levels beneath the tunnel exits (now underwater) were a contact and trip hazard with exposed landscape fabric</p> <p>Action Analysis <input type="checkbox"/> infill relevant box <input type="checkbox"/> Action immediately - now implement <input type="checkbox"/> Already actioned <input type="checkbox"/> Plan work and implement <input type="checkbox"/> Monitor - no action is currently required <input type="checkbox"/> Review</p> <p>Brief description of the work actioned e.g. repair, remove, replace, renovate, investigate, modify, fence off, clean, top-up</p>

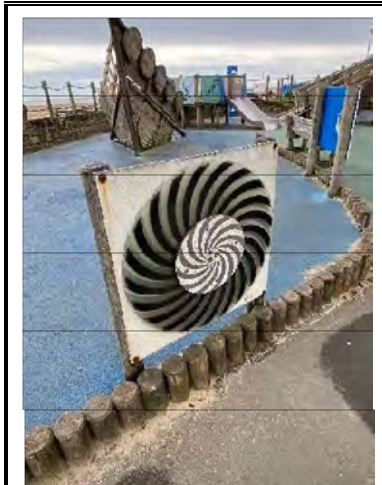
TOTAL	Risk level	Risk level	Risk level	Risk level	Risk level
Issues or hazards found					
	Trivial	Tolerable	Moderate	Substantial	Intolerable
		low	medium	high	immediate
9- Spinning visual wheel	1				1

RL Intolerable rotten post

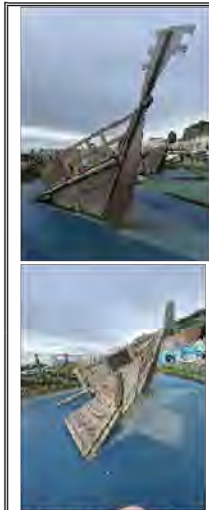
TOTAL	Risk level	Risk level	Risk level	Risk level	Risk level
Issues or hazards found	Trivial	Tolerable low	Moderate medium	Substantial high	Intolerable immediate
11- Broken ship	4	1	1	2

- RL Tolerable** With the mesh nets removed finger entrapments are left
- RL Moderate** New timbers have radius edges of less than 3mm
- RL Substantial** modified upper side design with railings has head entrapments
- RL Substantial** Newly provided guardrails need to be replaced by barriers.

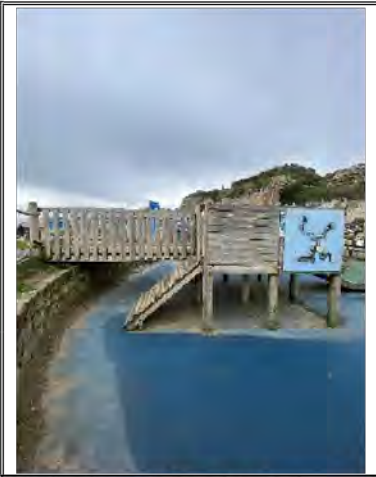
12-Central bridge structure	3			1	1
------------------------------------	---	--	--	---	---

12-Central bridge structure 3 1
 Central bridge structure - Timber elements are starting to rot and fixings have corroded

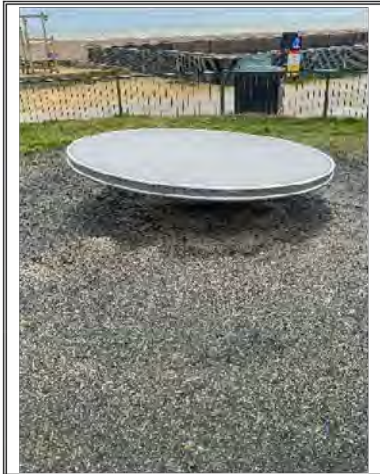
TOTAL	Risk level	Risk level	Risk level	Risk level	Risk level
Issues or hazards found	  Trivial	  Tolerable	  Moderate	  Substantial	  Intolerable
		low	medium	high	immediate
14- Carousel	3			2	1

RL Substantial	Significant areas of the IAS are damaged
RL Intolerable	Severe corrosion with indications of perforation to the underside of the carousel and central post
RL Substantial	trip points developing on top of a moving carousel

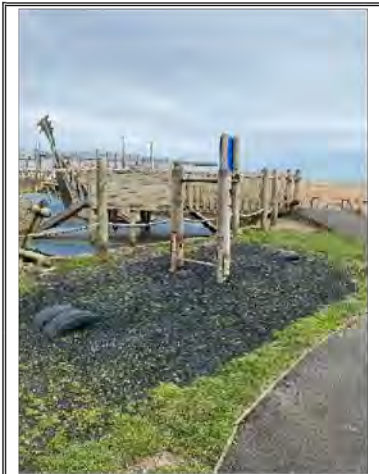
15- Rocker large standing seesaw moving element removed	2		1		
--	---	--	---	--	--

Issue removal of remaining framework and embedded tyres advised – issues of use for intended play activities leading to injury

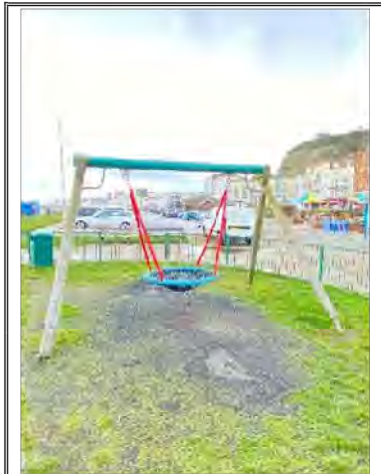
TOTAL	Risk level	Risk level	Risk level	Risk level	Risk level
Issues or hazards found	Trivial	Tolerable low	Moderate medium	Substantial high	Intolerable immediate
17- Swing 1 bay 1 group seat	2			1

RL Substantial 2 holes in IAS

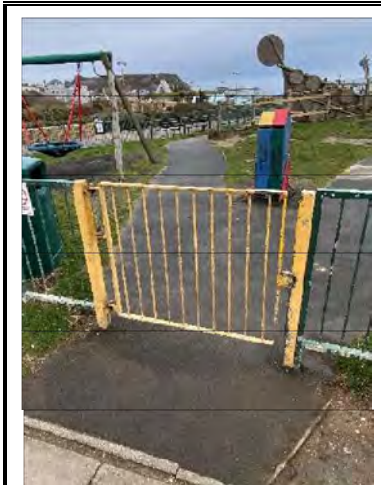
TOTAL	Risk level	Risk level	Risk level	Risk level	Risk level
Issues or hazards found	Trivial	Tolerable	Moderate	Substantial	Intolerable
		low	medium	high	immediate
18- Gate - west end	1		1

RL Moderate Buffer pad is timber and not deformable
