SCH-009 Alexandra Park, Hastings, Cycle scheme

East Sussex Highways

Combined Stage 1/2 Road Safety Audit

7th October 2019

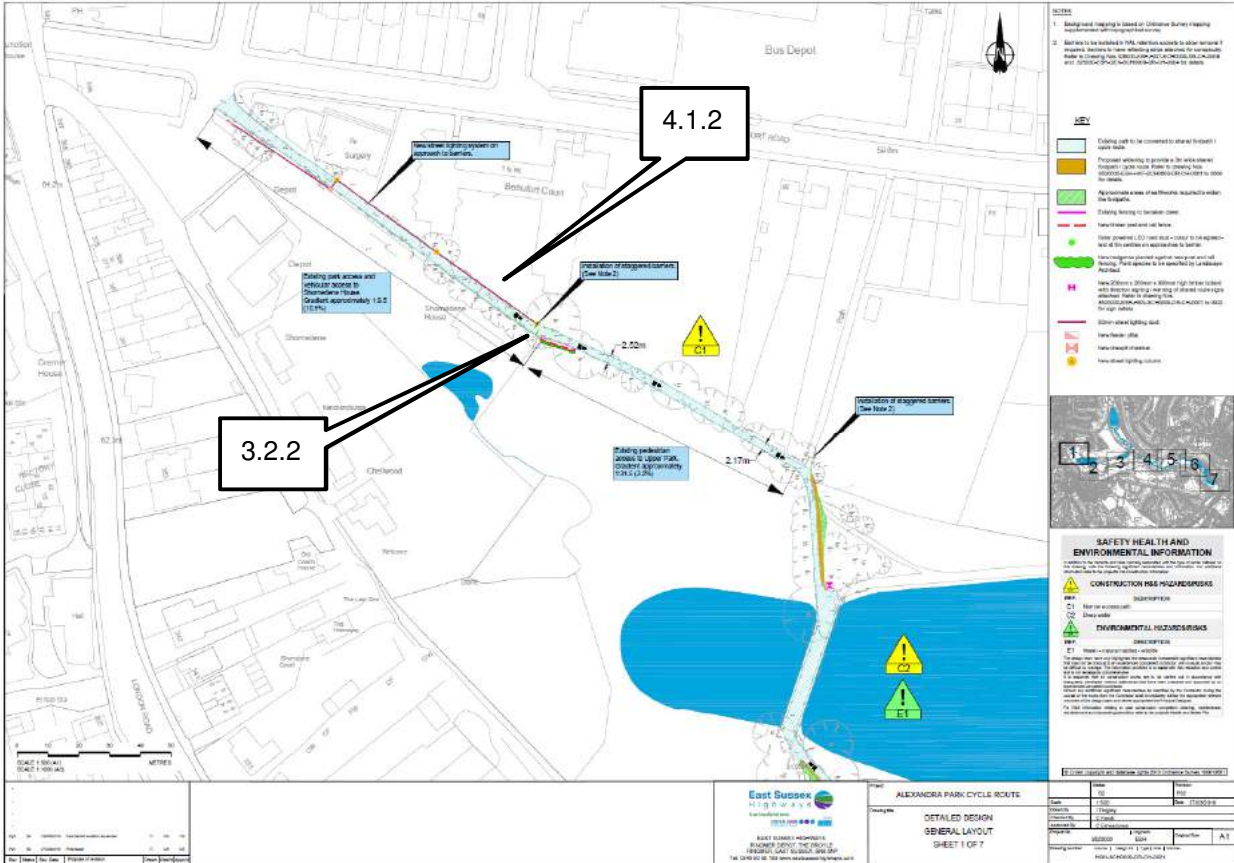
Appendix C. Key Plan

Issues throughout the scheme: 2.1.1, 3.2.1, 3.3.1, 3.3.3, 3.3.4, 3.3.5 (Lower Park only), 3.4.2, 5.1.1, 5.1.2, 5.1.3 and 5.2.1.
